## Technical Engineering Memorandum **Venetian Isles Community Development District** 2501A Burns Road, Palm Beach Gardens, Florida 33410

Submitted via email:  
October 6, 2023

## **Lake 4 – Photos and cross section(s) of recommended solution(s)**

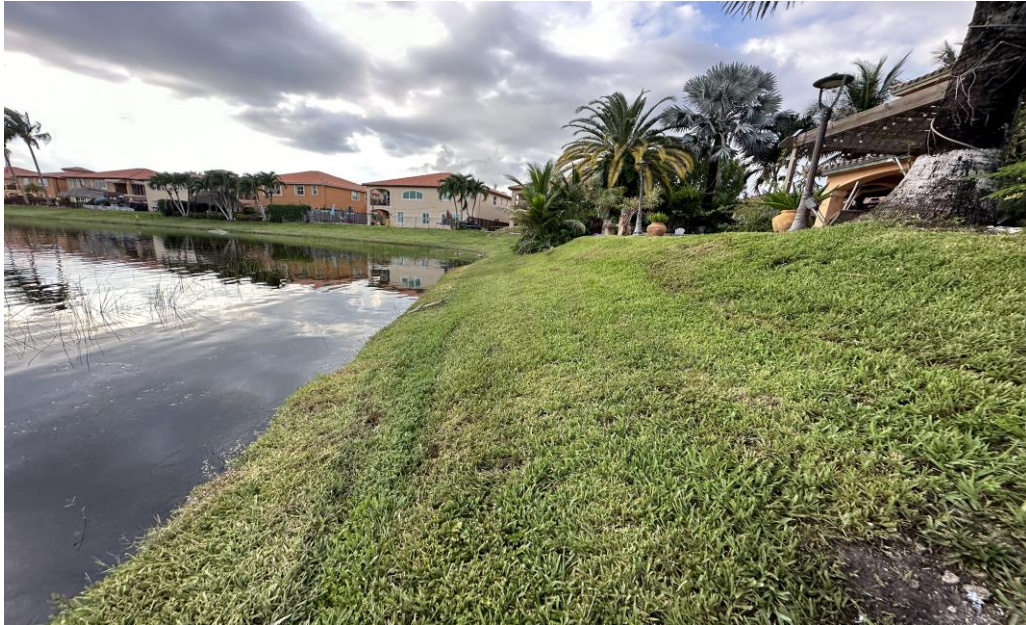
Based on our analysis, we recommend this lake's shoreline be the first to be restored, specifically on the residential side. We found that the slope from the top to the water's edge is very steep. In addition, at the edge of the embankment, there are steep drops of +/- 2 feet. If no action is taken, the shoreline will keep eroding at an accelerated rate, creating a steeper slope from the top because the soil will repose itself.

Figure 7: Bank erosion with steep drop from the top of the embankment.

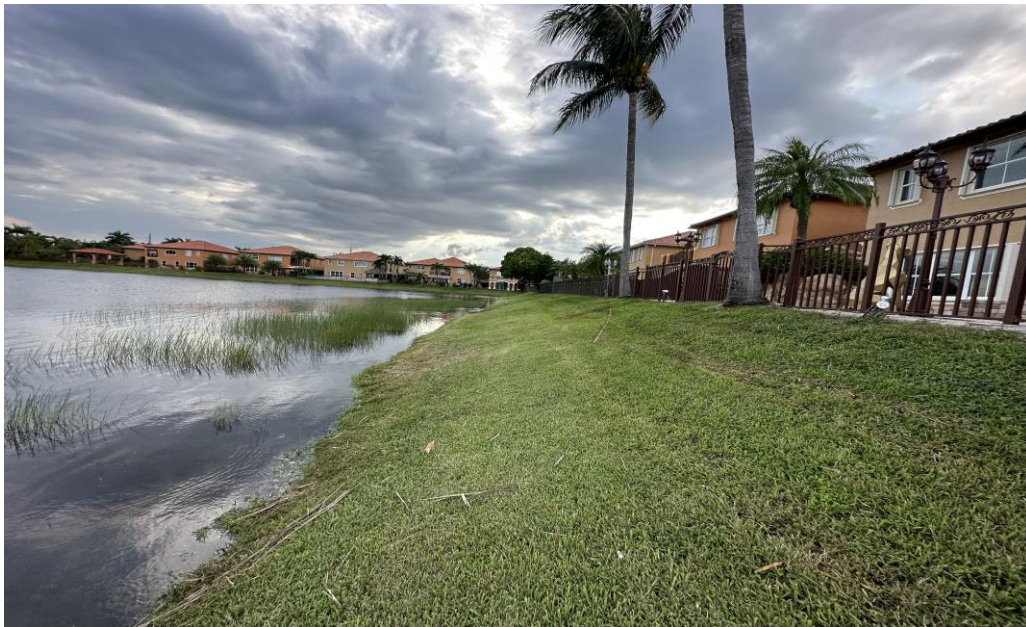
Figure 8: Bank erosion with uneven shoreline with a drop off at water's edge.

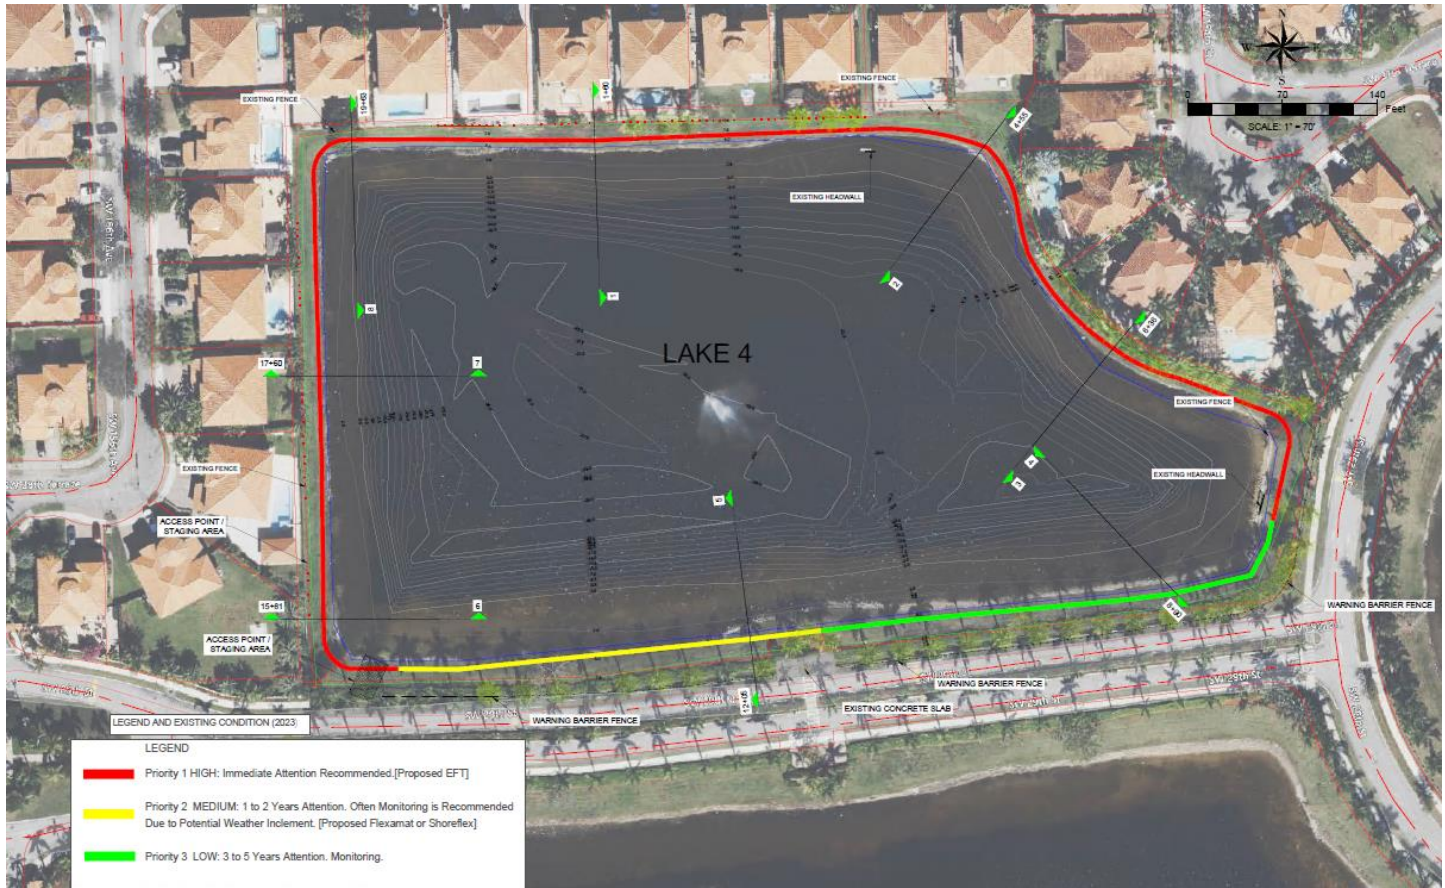
Figure 9: Aerial of recommended priority areas and recommended erosion control element.

- 1,511 linear feet of shoreline repair
- 3,392 sf of concrete block mat
- 1,087 lf of one (1) layer of 10' circumference base eco-filter tube
- 1,414 lf of two (2) layers of 10' circumference supporting eco-filter tube
- 1,818 cy of imported fill material to meet the berm requirement of 9.50 NGVD29
- 414 cy of imported fill material to fill in the eco-filter tubes

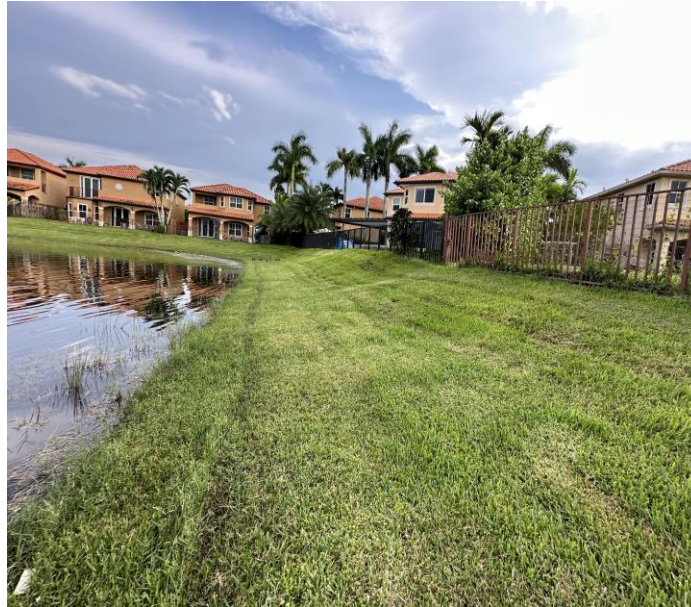
Figure 10: Uneven, soft soil.

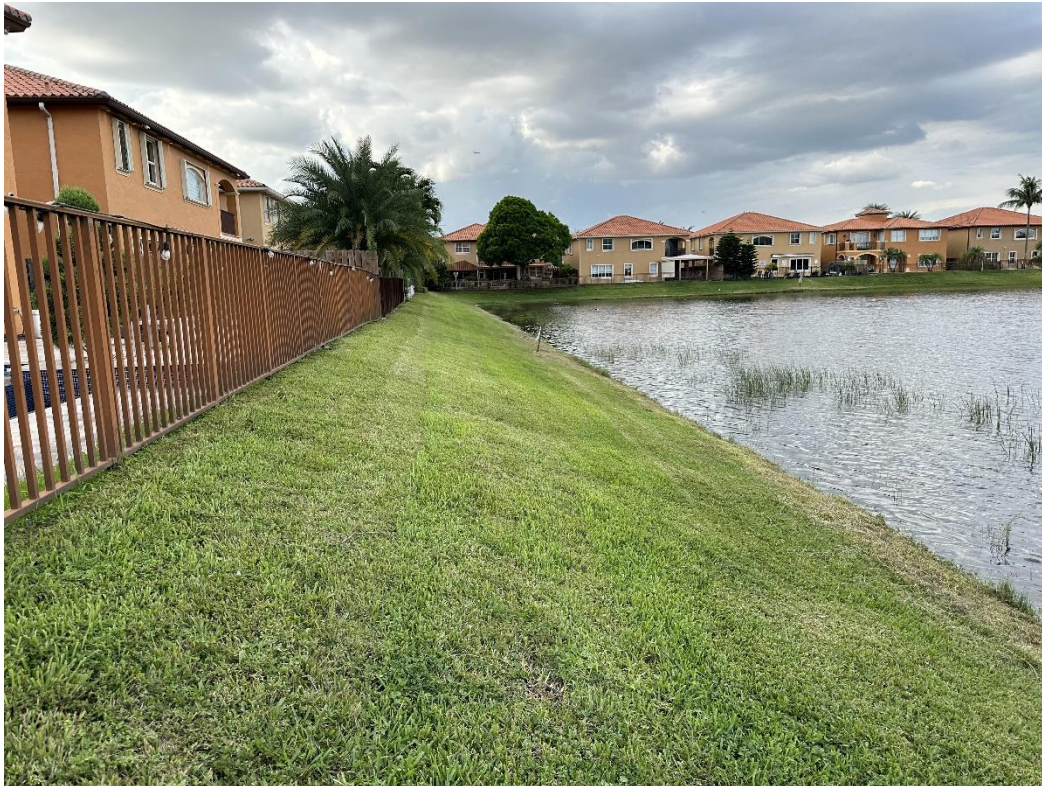
Figure 11: Steep slope with a drop off at the water's edge.

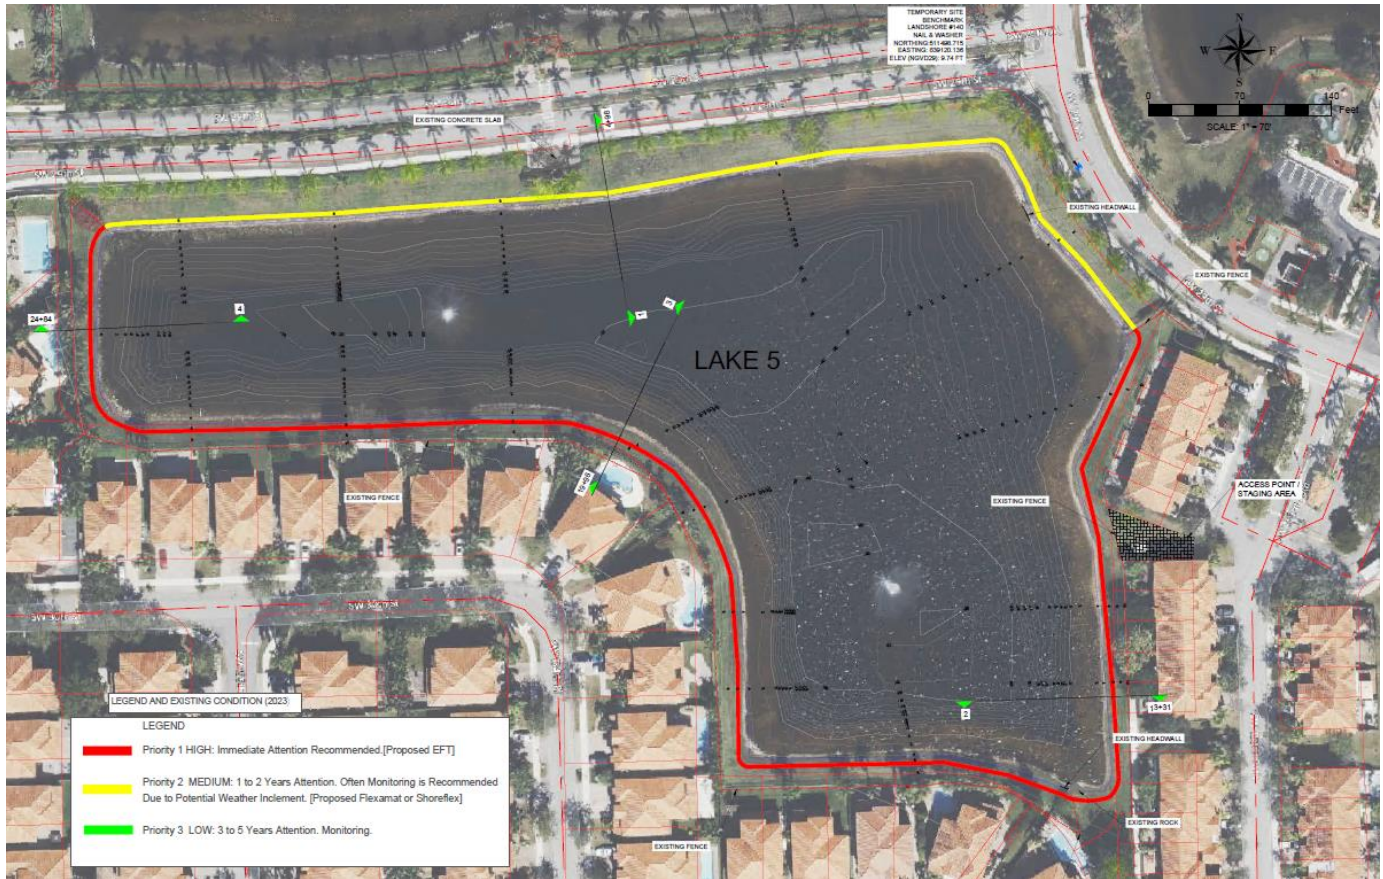
Figure 12: Aerial of recommended priority areas and erosion control elements.

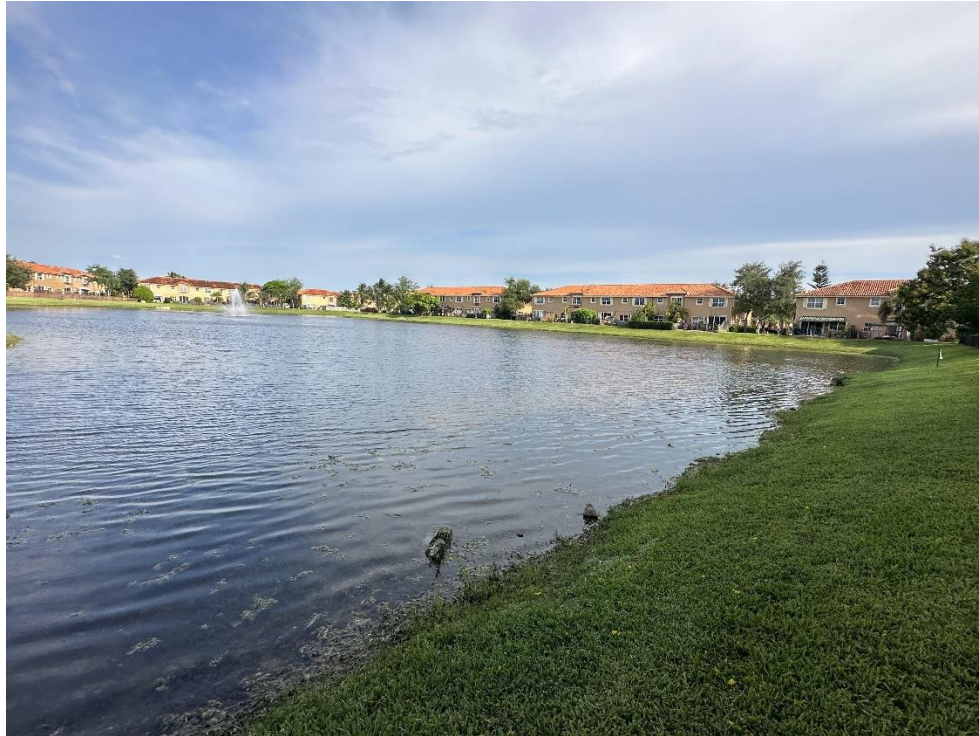
Figure 13: Cutouts along the embankment with a steep drop off.

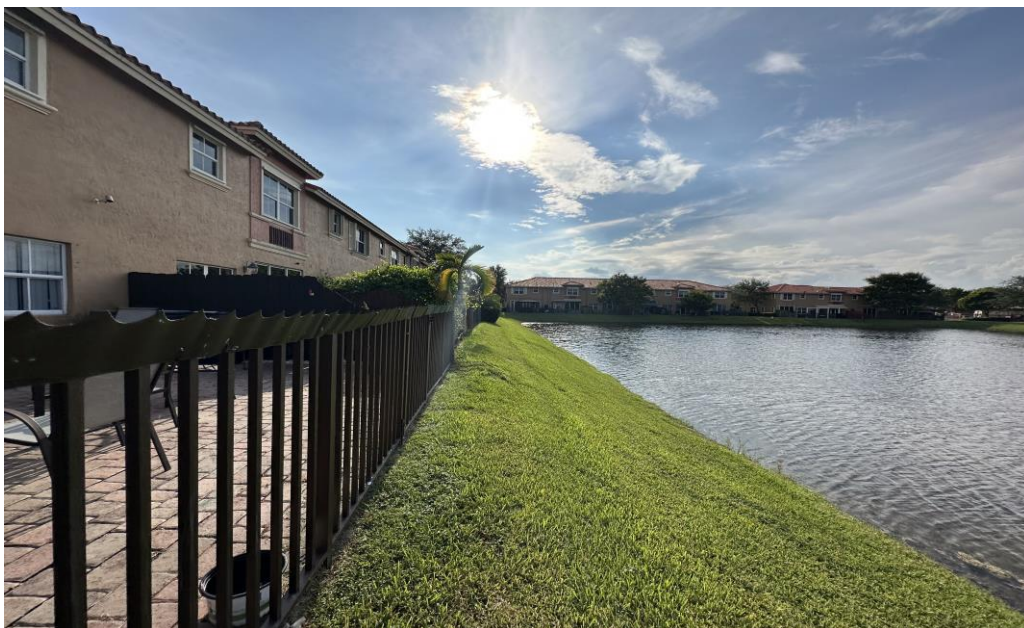
Figure 14: Steep slope from the top of the embankment to the water's edge.

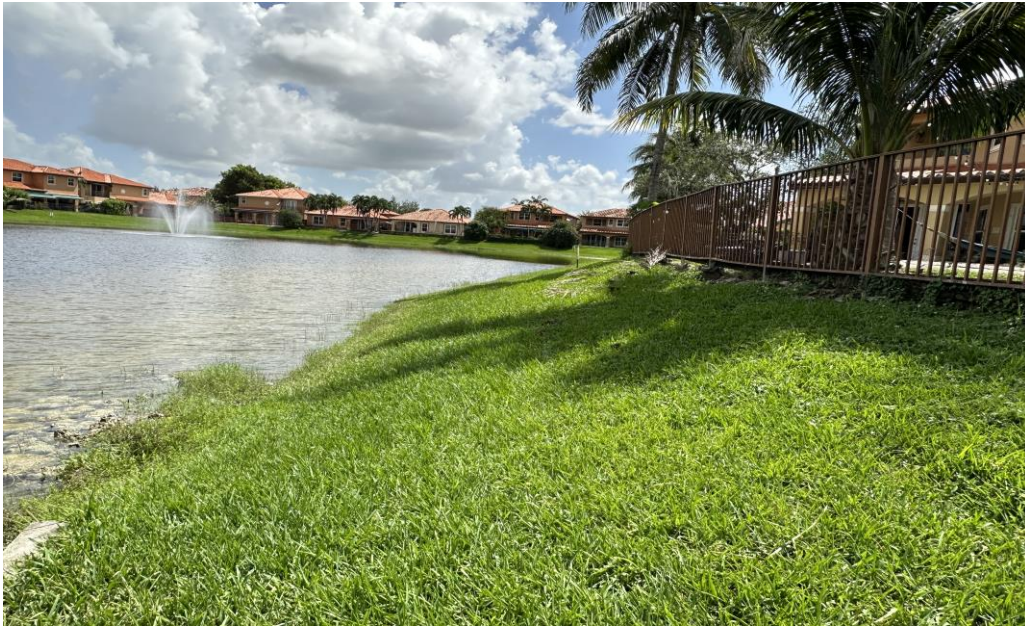
Figure 16: Loss of soil based on the concrete slab.

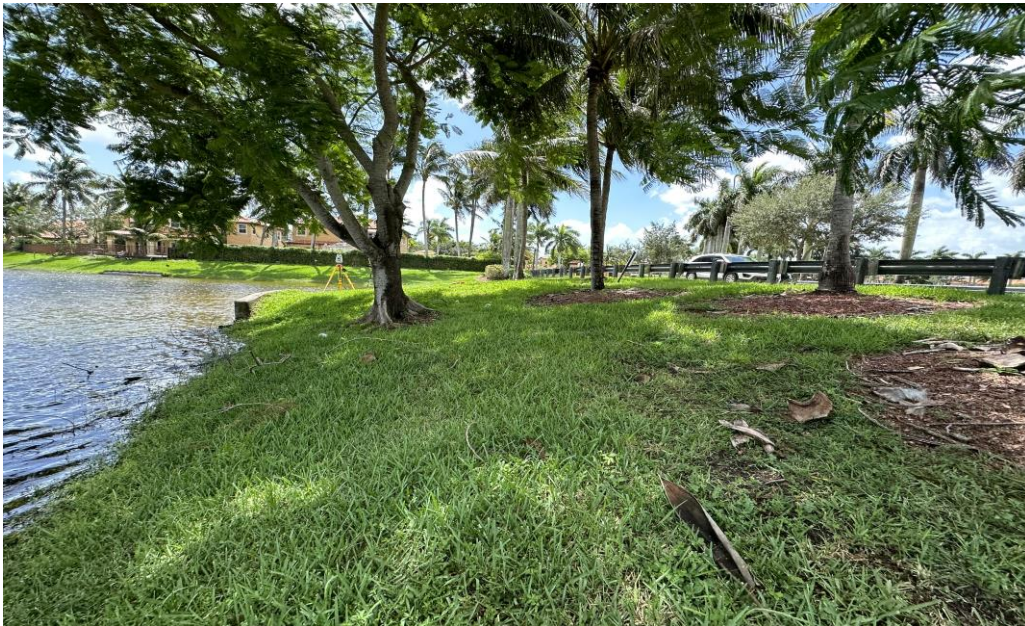
Figure 17: Bank erosion shows loss of land.

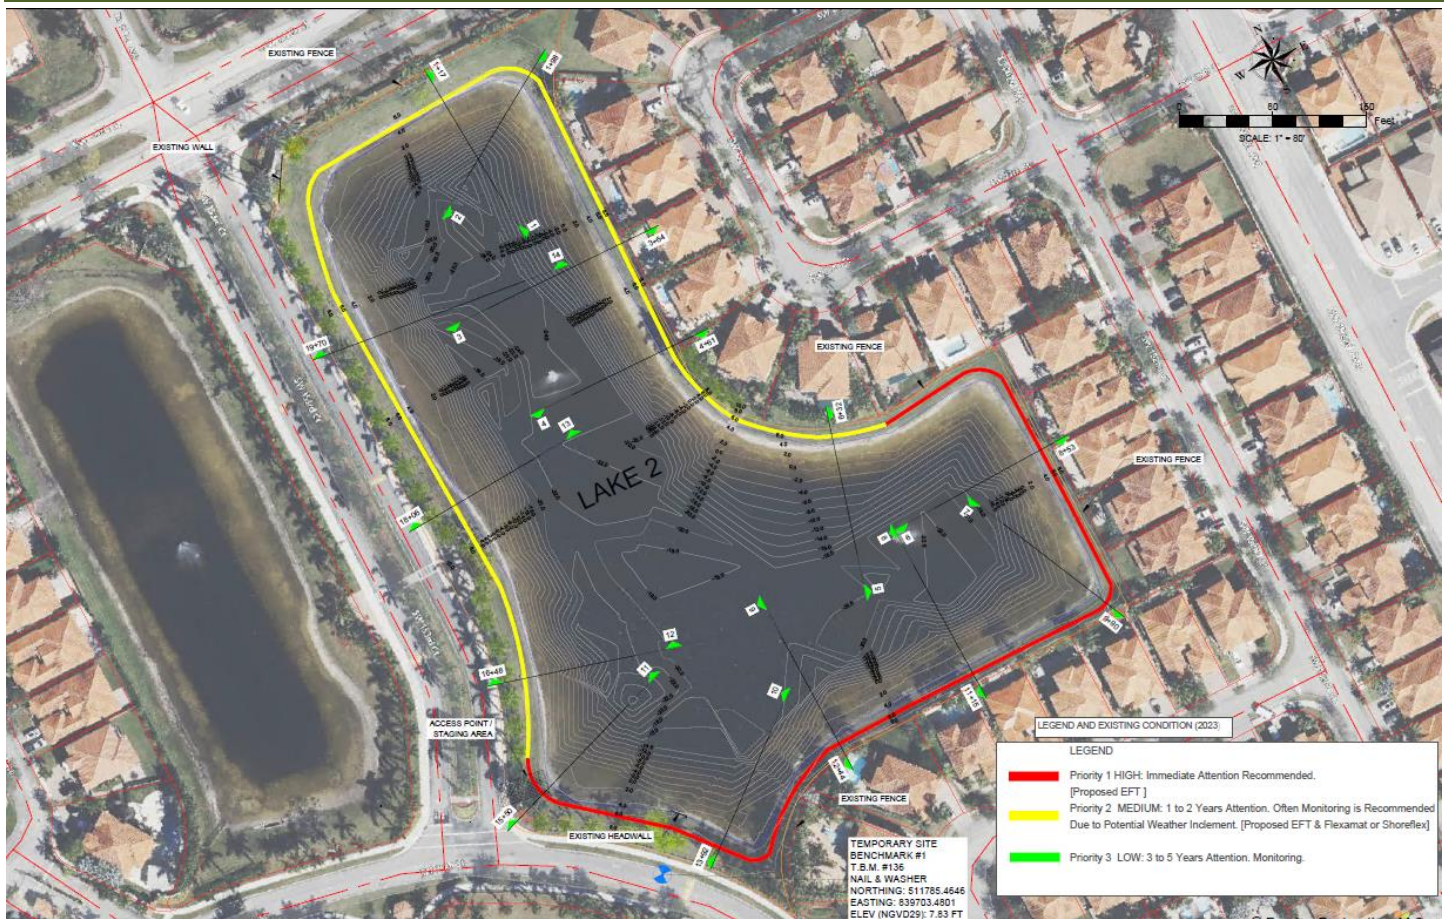
Figure 18: Aerial view of recommended priority areas and erosion control elements is shown.

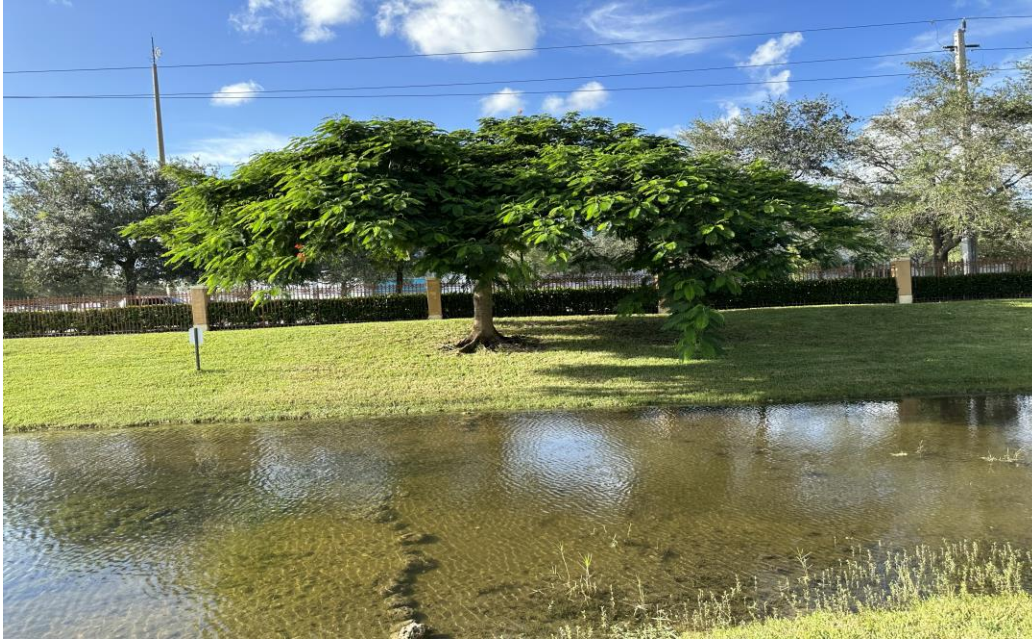
Figure 19: Observed soft organic material sedimentation.

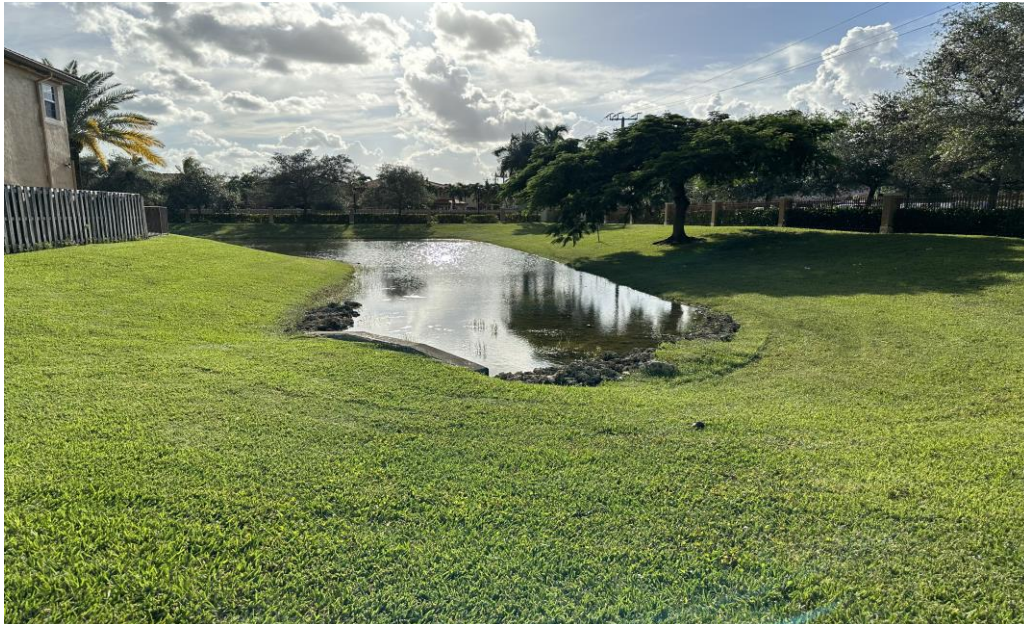
Figure 20: Bank erosion showing depression.

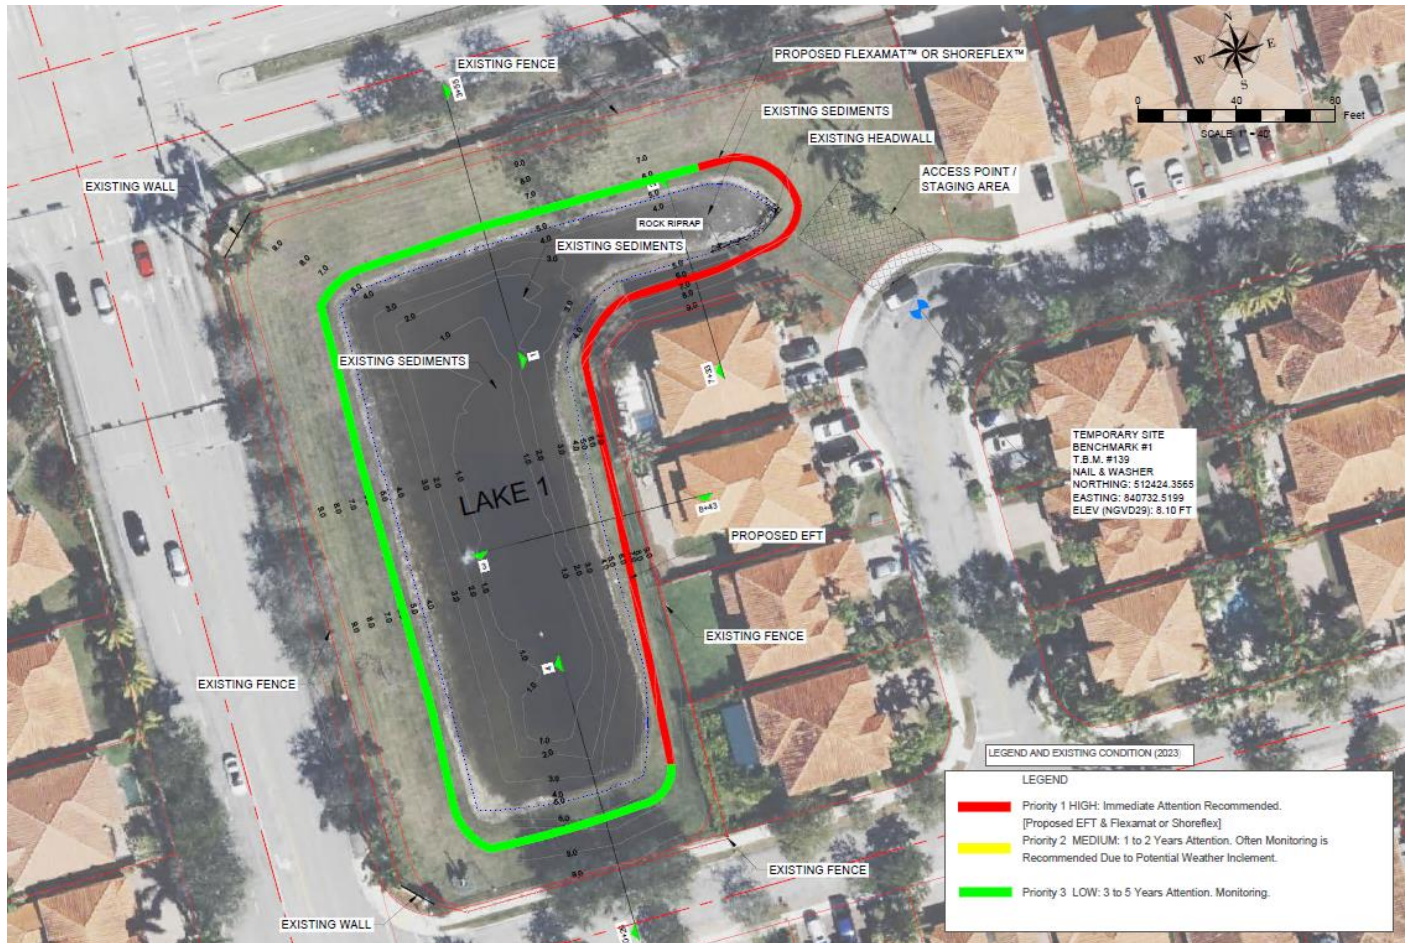
Figure 21: Aerial view of recommended priority areas and erosion control elements.

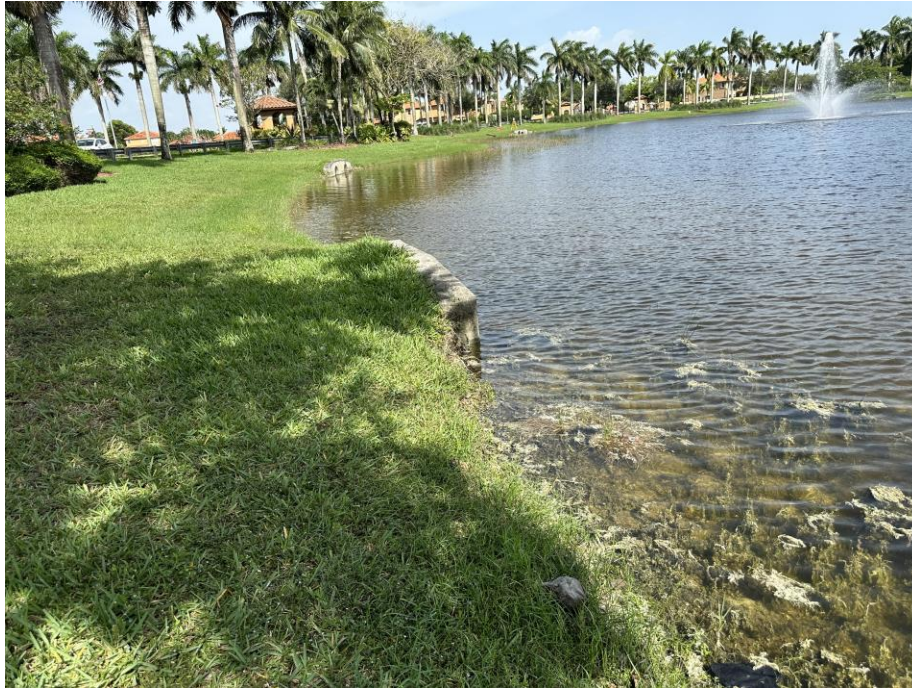
Figure 22: Slope is good; however, loss of land is shown.

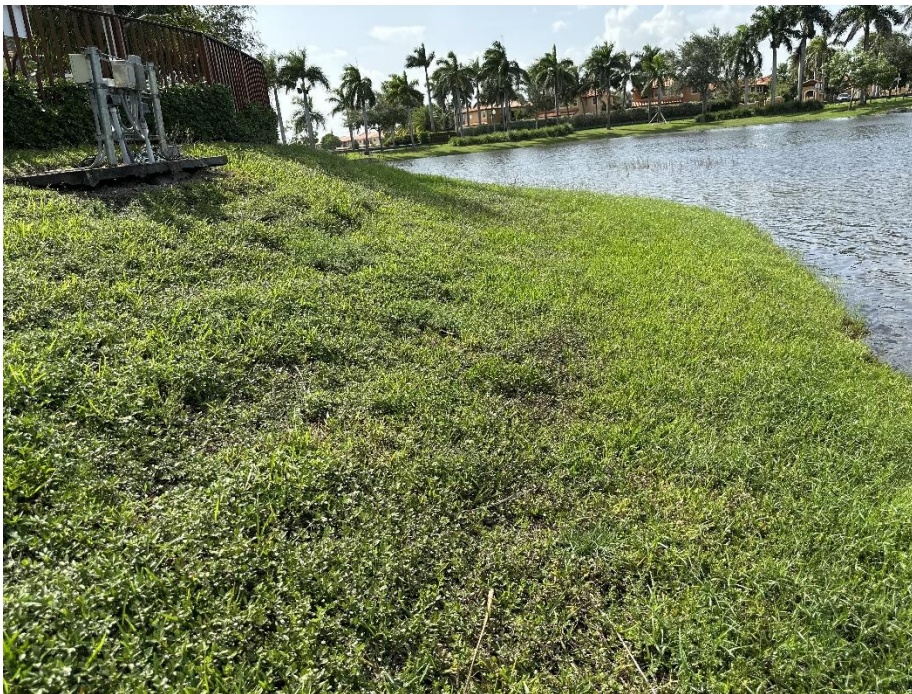
Figure 23: Good indication of soil reposing itself due to erosion.

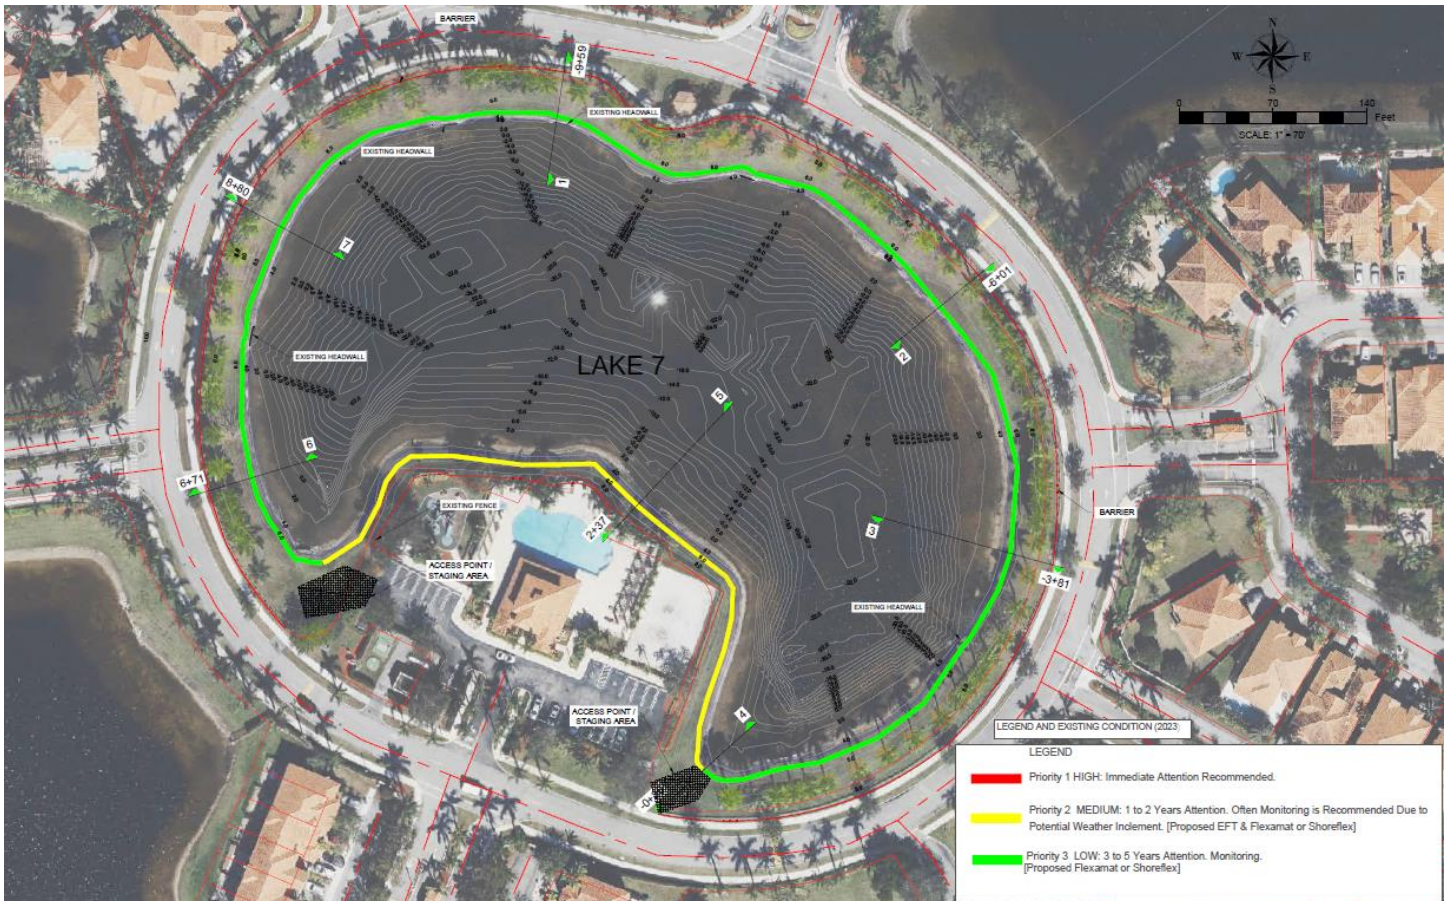
Figure 24: Aerial of recommended priority areas and erosion control elements.

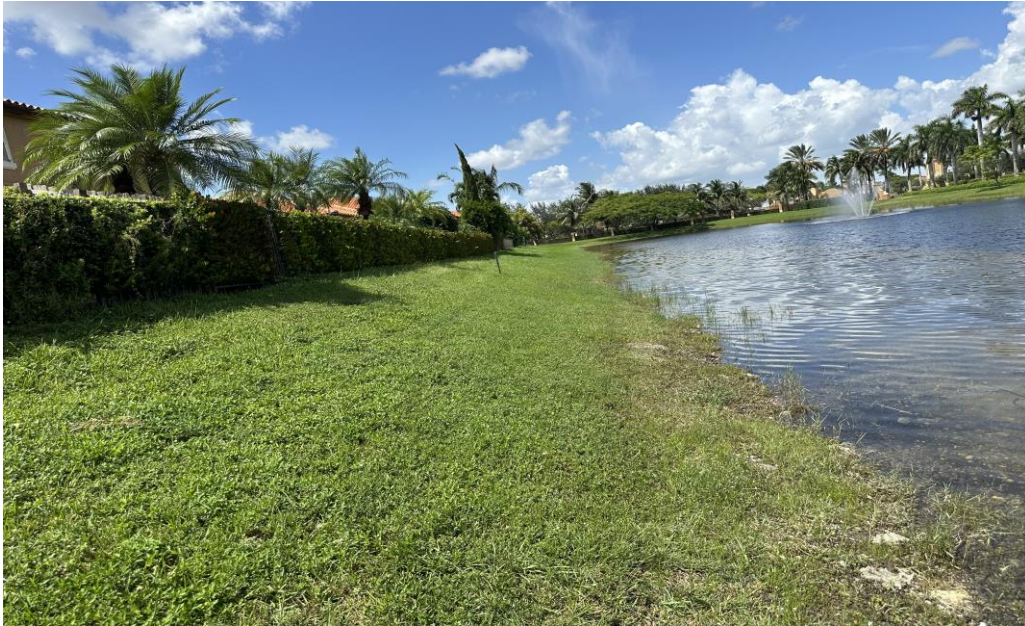
Figure 25: Slope is in good condition, however is not in accordance with original design.

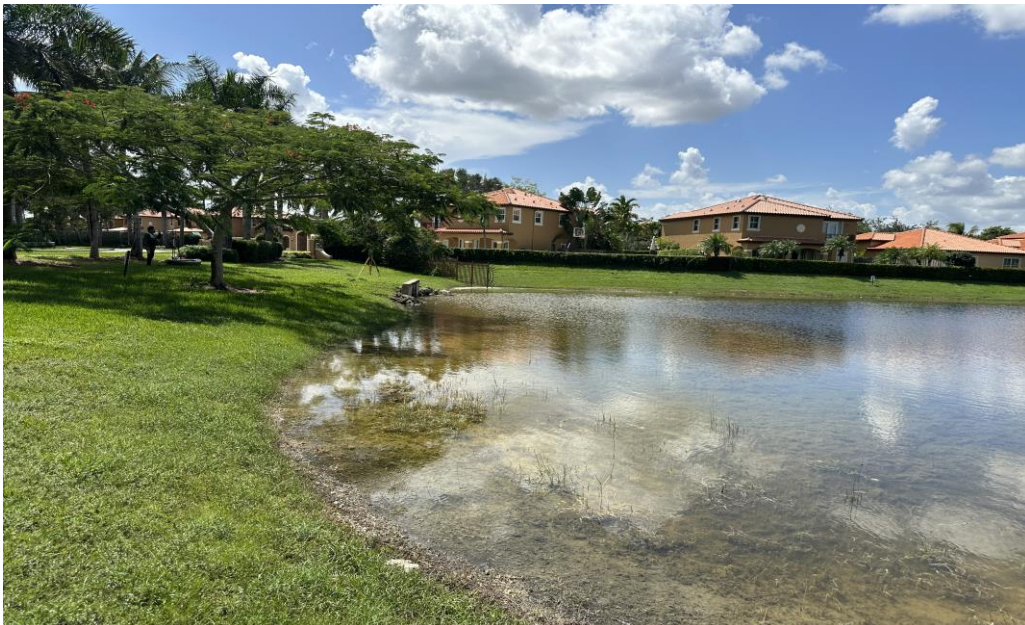
Figure 26: Slope is in good condition.
